CONDENSER TUBE FAILURE can occur for a number of reasons. However, we have been seeing an alarming number of new tubes coming in with manufacturing defects. Since the first two years of operation are critical, this is making an already difficult situation that much worse. Most owners are not aware of the problem until a failure occurs, and at that point, fingers are normally pointed at the water treatment company or the way the equipment was maintained. *The question becomes how many failures are due to tube defects?*

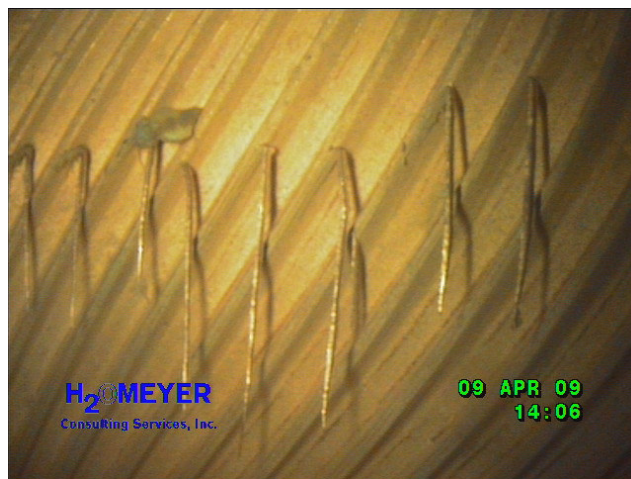
Attached to the right are pictures of a new machine recently installed at a customer site. Please note the defects in the tube enhancements and the tube corrosion at the bottom. These tubes have been pre-cleaned and the machine has not yet been placed in service. By identifying the tube defects early the client may address any warranty issues and adjust the treatment regime accordingly. The defects will create low flow areas making proper treatment extremely difficult and making early failures a strong possibility.

Row 30, Tube 41 – Manufacture defects of tube enhancements.

It is our recommendation that when a chiller is re-tubed or a new machine is installed that the tubes are cleaned, passivated, and visually borescoped to establish a baseline condition of the tube surfaces. The borescope should have the capabilities to take pictures at a 90 degree angle to detect defects or corrosion on the tube surfaces prior to putting the machine in service.

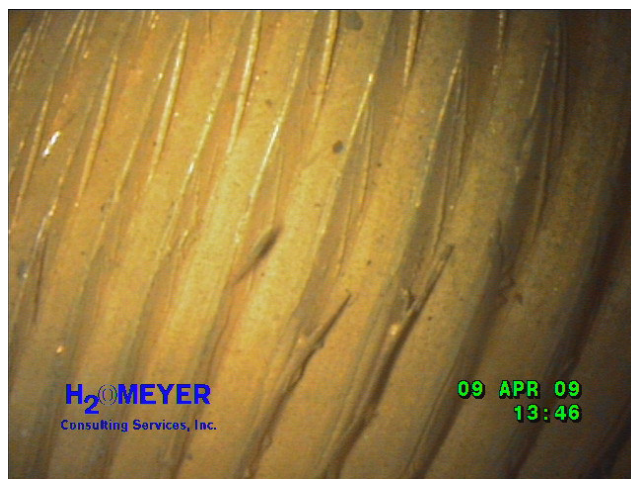
Row 15, Tube 24 – Manufacture defects of tube enhancements.

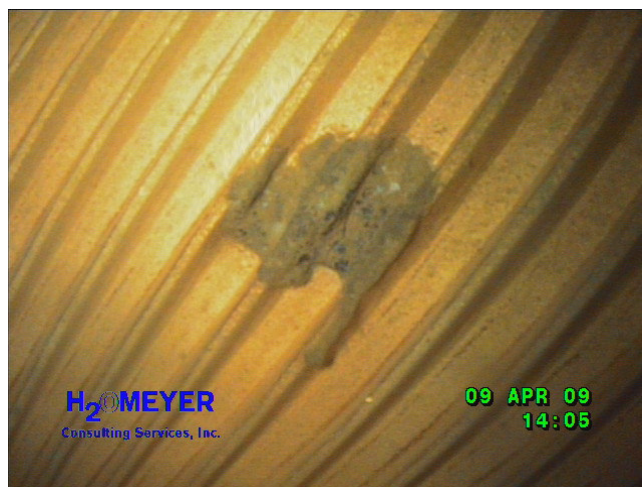
Row 30, Tube 41 – Some visible corrosion.
